# Applicability of the Visual Screening for Buildings Safety against Earthquakes

～A Case Study on Hatay, Antakya, Turkey～

Graduate School of Societal Safety Sciences

Vladimir Enrique GUZMAN JAVIER

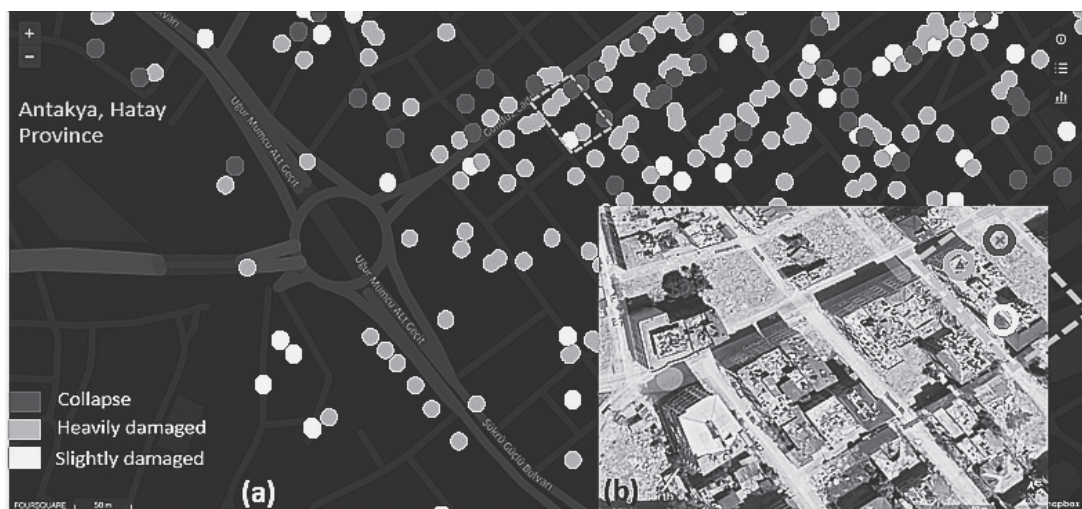
Figure 1 shows a close-up view of the identified location of houses and damage levels in Hatay. Herein, “collapsed” is defined as a

building in ruins, “heavily damaged” as concrete construction destroyed, and “slightly damaged” as repairable buildings after the seismic event. See the details in the reference<sup>[15]</sup>.

Figure 1. Example of the identified location of houses and damage levels considered in Hatay (Close-up view).

(a) 2023 Turkey Earthquake Building Damage Assessment Map<sup>[14]</sup> (with editorial changes in color)  
 (b) Damaged buildings from satellite images. (Google Earth)

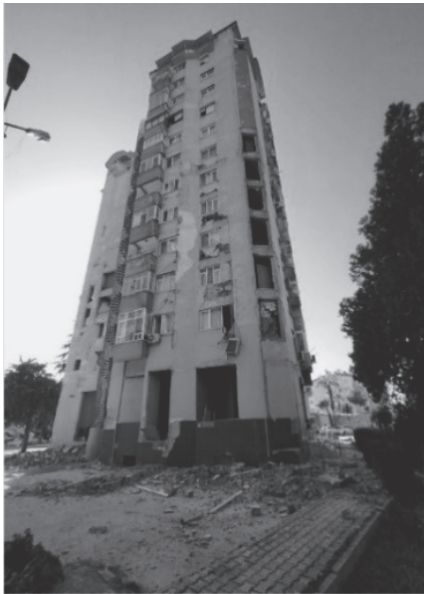
Figure 2 is an example of a building image from the road nearby in the study area. This photo was taken after the 2023 Turkey-Syria Earthquake, and the building was categorized as slightly damaged.

Figure 2. Example of building image from roads nearby.

For example, the building shown in Figure 2 is a system-type C3, which corresponds to reinforced concrete buildings with unreinforced masonry infills and RC buildings with concrete shear walls. And most of the buildings in the study area were of this type. Based on the FEMA sheet presented in Figure 3, first, the building type was identified as RC buildings, thus system type C3 was selected. The basic score for this type was 1.2. Then, a score modifier of  $-0.7$  was assigned for the severe irregularity.

These are the procedures used to evaluate the score from Google Street View images. And as an example, the final score of 0.4 was assigned to the building shown in Figure 2.

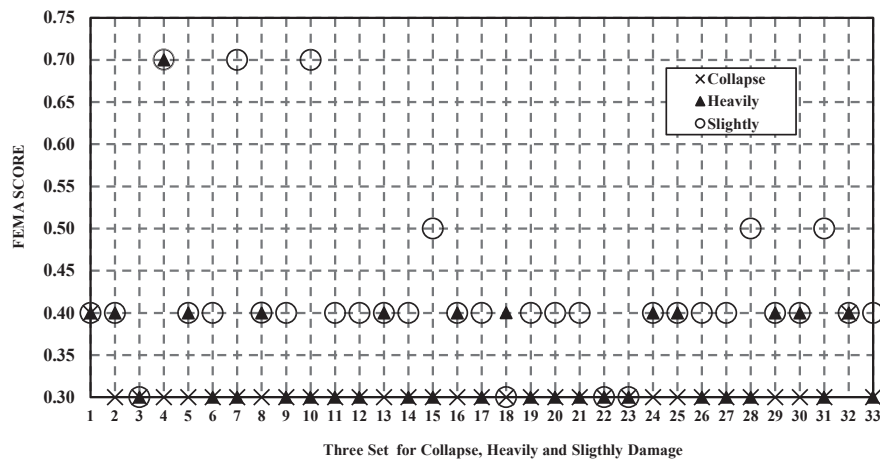
From Figure 6, it can be observed that most collapsed buildings have a 0.3 score. In contrast, most of the slightly damaged buildings are 0.4 or more. And the scores for heavily damaged are between these, except for set 18. In the majority, the score of heavily damaged buildings is less or equal to the score of collapsed buildings. In addition, the score of slightly damaged is less or equal to the score of heavily damaged buildings. Interestingly, FEMA scores are equal in three sets for col-

lapsed, heavily and slightly damaged, particularly in sets 1, 3, 22, 23, and 32. This is because the difference cannot be identified from the visual screening for this data. For example, it can be the difference that comes from the level of deterioration on the interior of the structures.

Figure 6. Comparison of the FEMA Scores of each Set of Buildings.

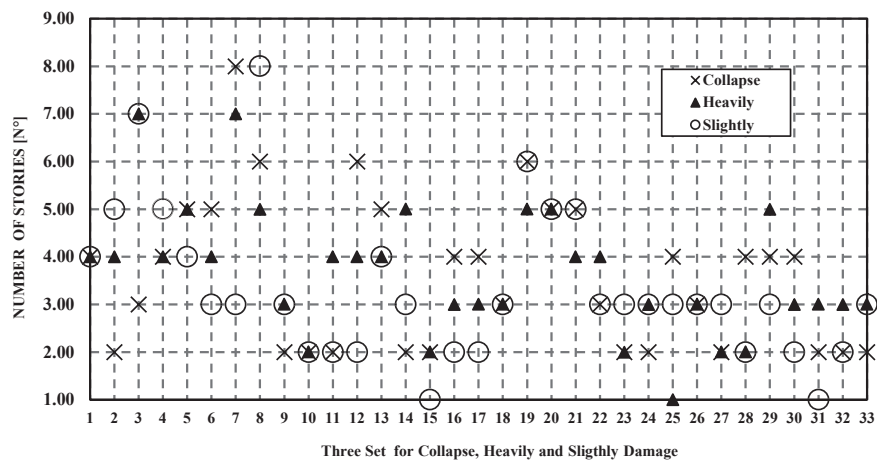
Figure 7 shows that the 2 buildings with 8 stories are the tallest. And one was collapsed, but the other was slightly damaged.

Figure 7. Comparison of the Number Stories of each Set of Buildings.

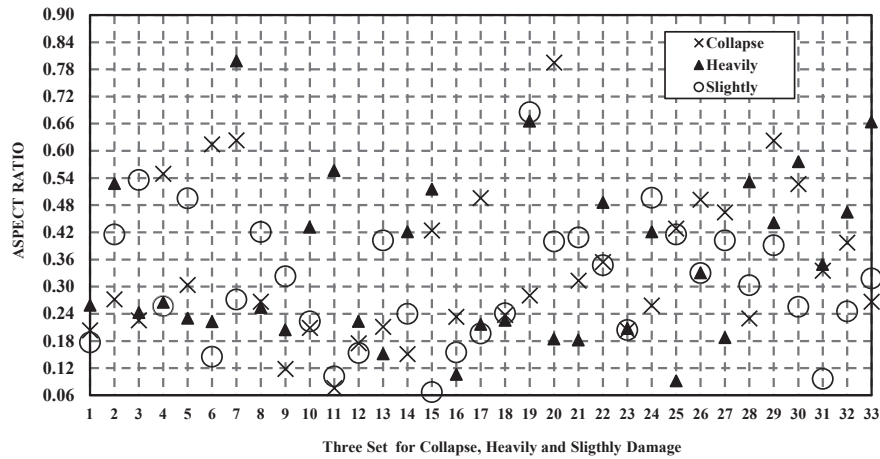
Figure 8. Comparison of the Aspect of Ratio of each Set of Buildings.

buildings can be discussed. In set 20, the slimmest building was collapsed. However, in set 19, the building with the smallest aspect ratio collapsed.

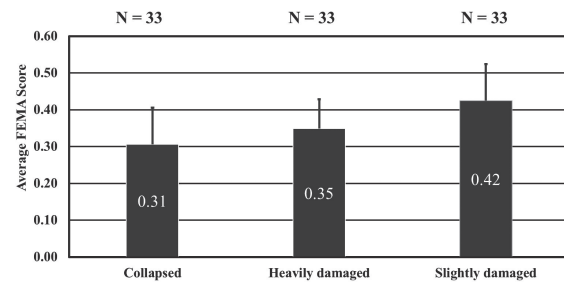
Figure 9 shows the comparison of the average FEMA scores in building groups. The building group with less damage shows a higher FEMA score. We have applied ANOVA (Analysis Of Variance)<sup>[20]</sup>, to check the significance of the trend. This trend is statistically significant since the  $p$ -value is quite small ( $p=2.80 \times 10^{-8}$ ).

Figure 9. Average FEMA Score per level of damage.

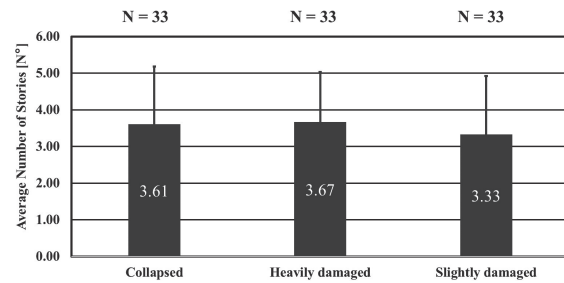
Figure 10 shows the comparison of the average in the Number of stories in building groups. The building group with less damage tends to have a smaller number of stories. However, this trend is statistically insignificant from statistical verification with ANOVA ( $p=0.63715$ ).

Figure 10. Average Number of stories per level of damage.

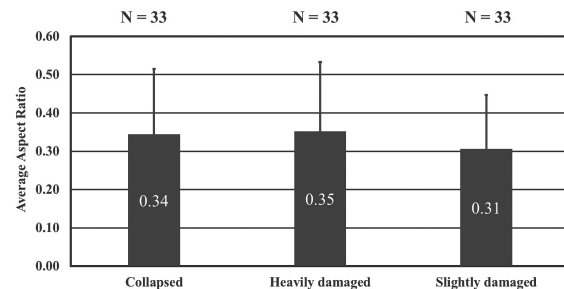
Figure 11 shows the comparison of the average aspect of ratio in building groups. The building group with less damage tends to have a smaller aspect ratio. However, this trend is statistically insignificant from statistical verification with ANOVA ( $p=0.48511$ ).

Figure 11. Average Aspect ratio per level of damage.
