# Applicability of the Visual Screening for Buildings Safety against Earthquakes

～A Case Study on Hatay, Antakya, Turkey～

Graduate School of Societal Safety Sciences

Vladimir Enrique GUZMAN JAVIER

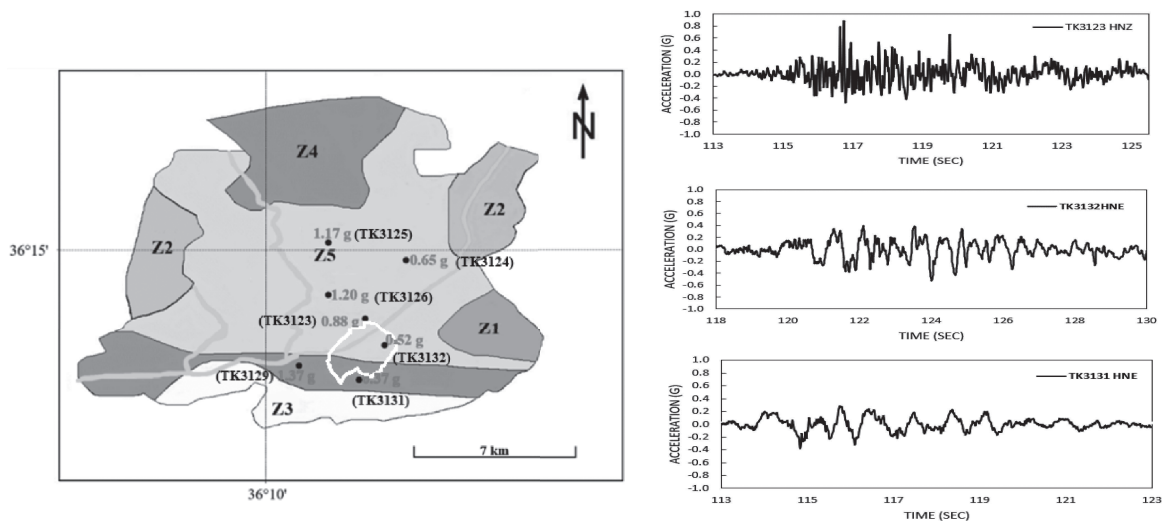
The study area was the city's center as shown in the white lines in Figure 4. The city's main roads were used to define the area as shown in Figure 5. From the microzonation map of Hatay Province<sup>[17]</sup>, this area was located in Zone 4 and Zone 5.

There were seven(7) strong motion observation sites near the area, as shown in Figure 4. The observed shaking level of the M7.7 earthquake (PGA: Peak Ground Acceleration) of the area was about 0.37 g to 0.88 g, although stronger shakings beyond 1 g were observed outside of the area. And, the difference of shakings within the study area was not significant. As shown in Figure 4, the seismic waveforms observed around the study area were not so different except for the

Figure 4. The study area (white polygon), microzonation of Hatay<sup>[17]</sup>, and strong motion observation sites nearby (black dot)<sup>[18], [19]</sup>.

high-frequency component observed in TK3123, where a spiky peak provided a larger PGA. Note that, although the difference in high-frequency shakings remained, our methodology of picking up all three different damage levels of buildings nearby can minimize the effects of these shaking differences in the study area.

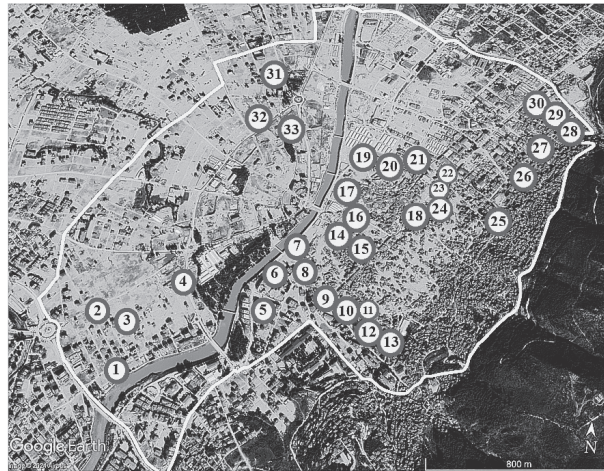
Figure 5. Summary of picked-up buildings in the study area., 99 damaged buildings with three levels of seismic damage (33 sets) on satellite images.

Figure 5 shows the summary of picked-up buildings. There are 99 damaged buildings with three levels of seismic damage (33 sets).
